**CONDITION SURVEY
REPAIR AND REHABILITATION
LOCK AND DAM NO. 24, MISSISSIPPI RIVER**

Richard L. Stowe, Henry T. Thornton, Jr.

**Structures Laboratory
U. S. Army Engineer Waterways Experiment Station
P. O. Box 631, Vicksburg, Miss. 39180**

August 1981

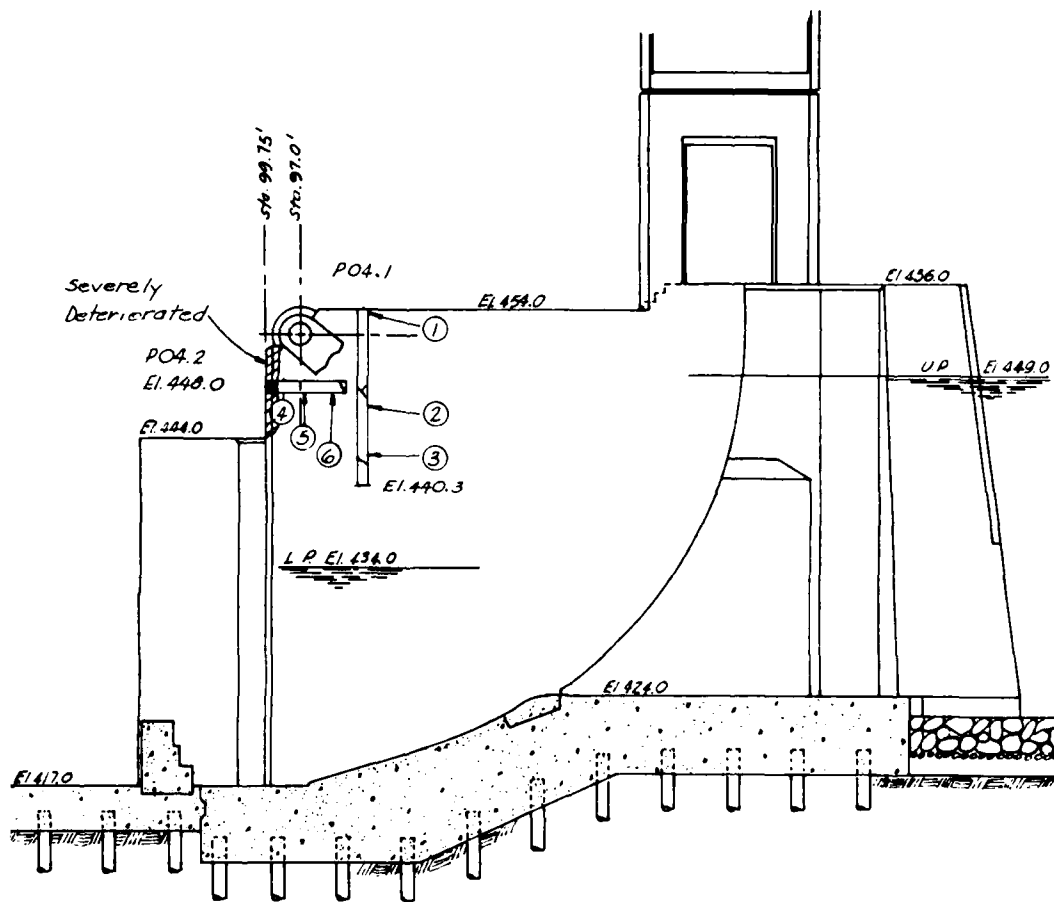
CROSS SECTION PIER #4

37. Cross sections for the three piers (No. 4, No. 9, and No. 15) in which vertical and horizontal borings were drilled are presented in Plates 12, 13, and 14. A small zone of severely deteriorated concrete exists below and downstream of the trunnion shaft for the full 10-ft

width of the pier. The zone extends from station 99.75 ft to a maximum depth at station 98.5 ft in pier No. 4. In pier No. 9 the zone is 0.9 ft deep and in pier No. 15 the zone is 0.4 ft deep. The depth of the zone could be deeper in the piers not drilled. Major cracks in the core recovered from the piers are presented on these three cross sections. The cracks help to explain some of the "no readings, NR," in the downstream portions of the piers.³ Plate 13b shows the location of the ultrasonic velocity measurements taken on pier No. 9 and the cracks observed in borings S WES P09.1 and P09.3. The uppermost crack in P09.1 could account for the "no reading" at stations No. 6 and 7. This plate also indicates that other "no readings" are accounted for by the anchor-
age steel; the interface between the concrete, plastic cork, and the steel would attenuate the transmitted pulse. The in-place velocities obtained by Thornton³ compare well with the velocities recorded on the laboratory test specimens.

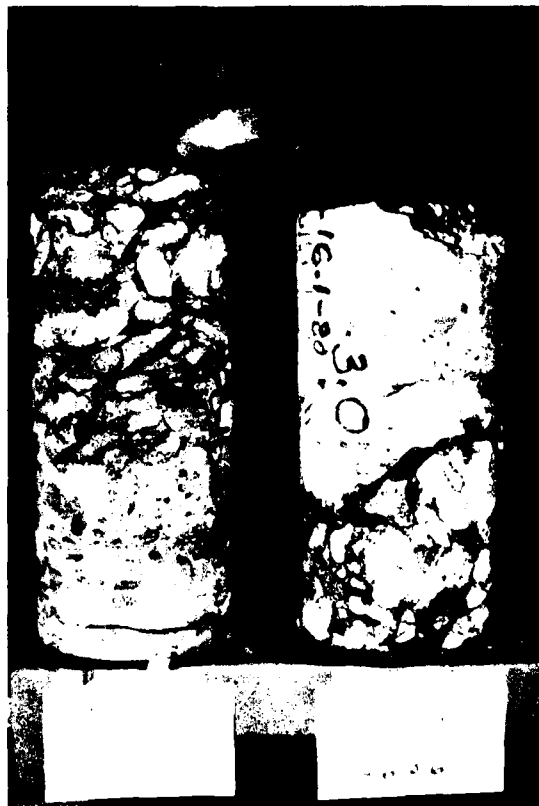
Photograph of SWES C16.1S showing damaged concrete core
representing the outside and backside of column No. 1
on pier 16
